Experimental Fatigue Test for Pre-Qualification of Repair Mortars Applied to Historical Masonry

Alessandro Grazzini

Abstract

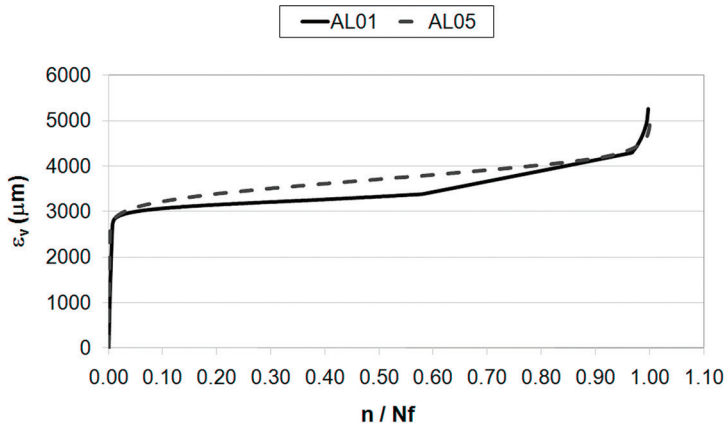
Figure 6. AL series cyclic tests: max vertical deformation.

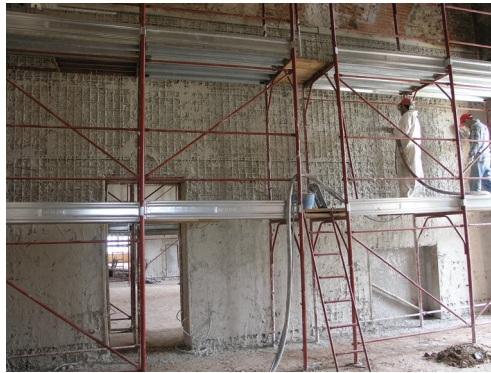
Figure 15. Application of mortar D as the reinforced plaster to Venaria's masonries.

came from the real application of mortar D as reinforced plaster retrofitting of some walls of the Royal Palace of Venaria (**Figure 15**). After 10 years, this plaster does not present any pathology of incompatibility.
